American Coating Technologies was contacted by Main Care Energy to make a site visit at their Greenwich location, for the purpose of evaluating their secondary containment for the storage of fuel oil. Main Care had recently been inspected by the New York State Department of Environmental Conservation, and had a few areas which needed to be brought up to code.

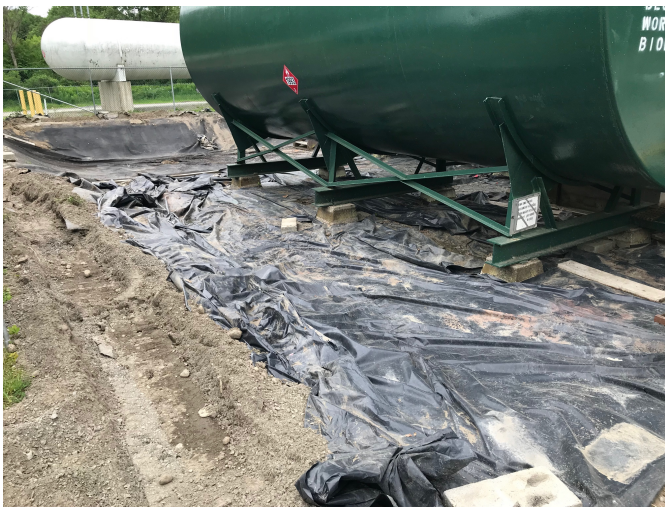
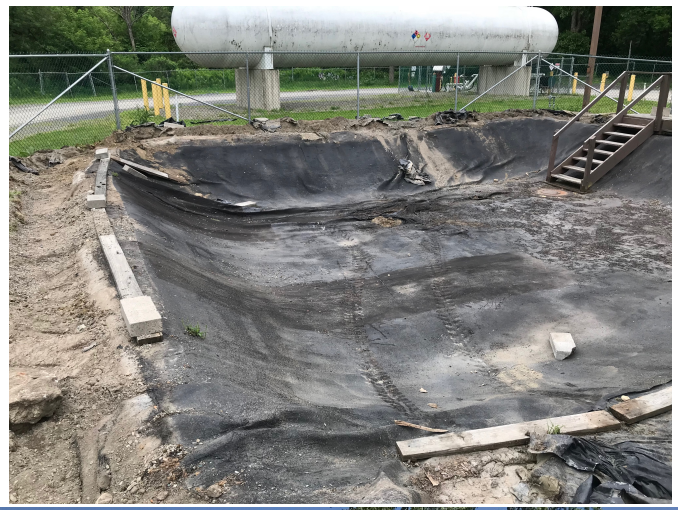
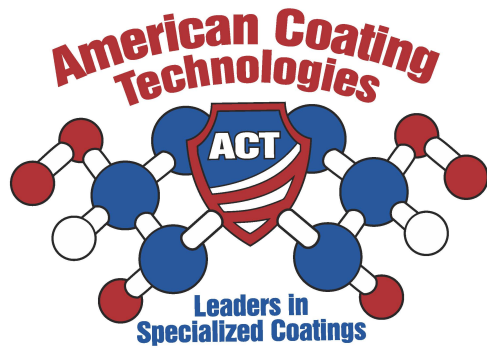
The old system used high density polyethylene and after years of exposure to ultraviolet light and the harsh winters, the liner had failed.

We knew that the area was going to be re-inspected very soon, so we installed the entire liner system the following week.
