# american coating technologies

## SECONDARY CONTAINMENT

**Client** | Buckeye Partners, L.P.; Brooklyn, New York

**ACT Product** | Seamless Polyurea Liner

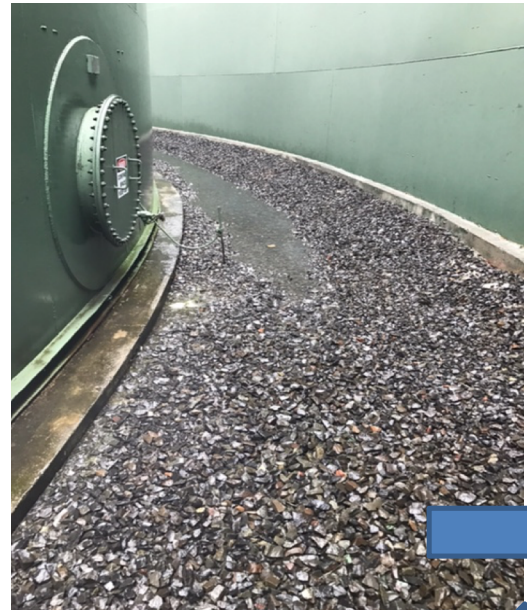
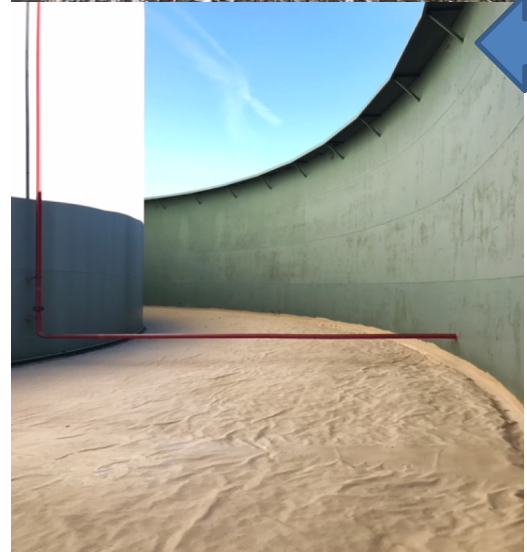
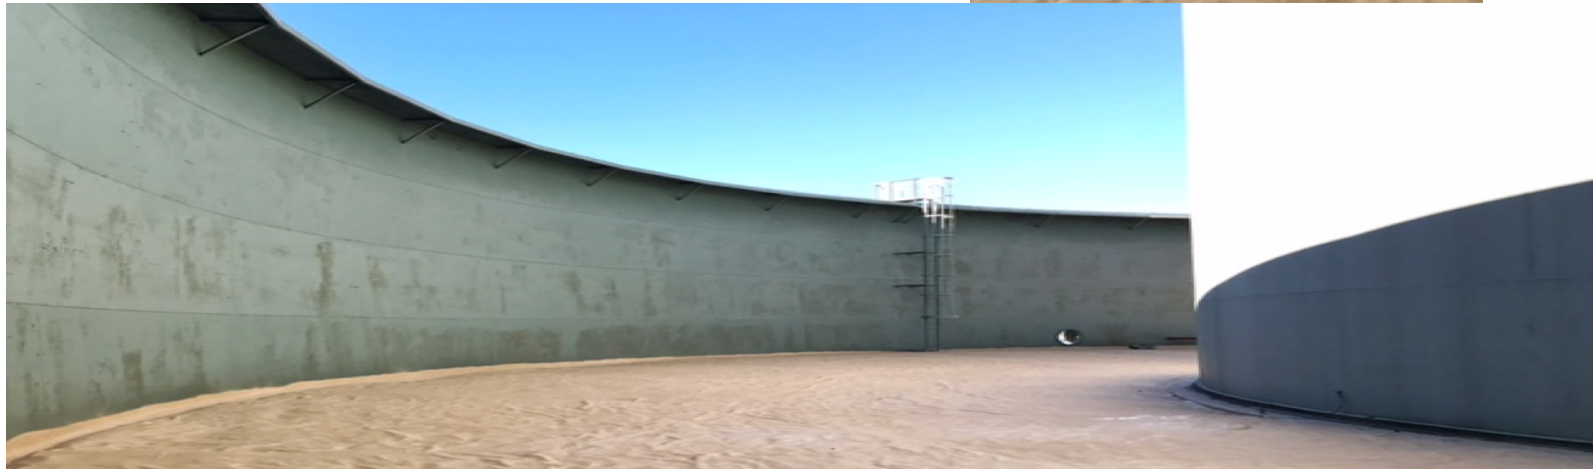
This terminal had a clay base that did not seal tight to the tank, piping, stairs and the drain. This is the biggest problem with these old containments. The clay was covered by 6 to 8 inches of stone and in order to repair this liner all of the stone and clay needed to be removed at a COST of \$100 per square foot. The estimated repair area was 100 square feet, but again it was not possible to determine the extent of the damage until repairs start and there was no warranty.

American Coating Technologies installed a poly urea seamless liner system over the entire secondary containment area (15,000 sq. ft.) in five days at a cost of \$3.78 per square foot. This system came with a complete 10-year warranty for both the liner material and all the labor required for any repair.
